# REQUEST FOR PROPOSALS

**THE DRAKE APARTMENTS  
3060 N. MERIDIAN STREET**

RFP-13DMD-2023-6

# HISTORIC AREA PRESERVATION PLAN – 43

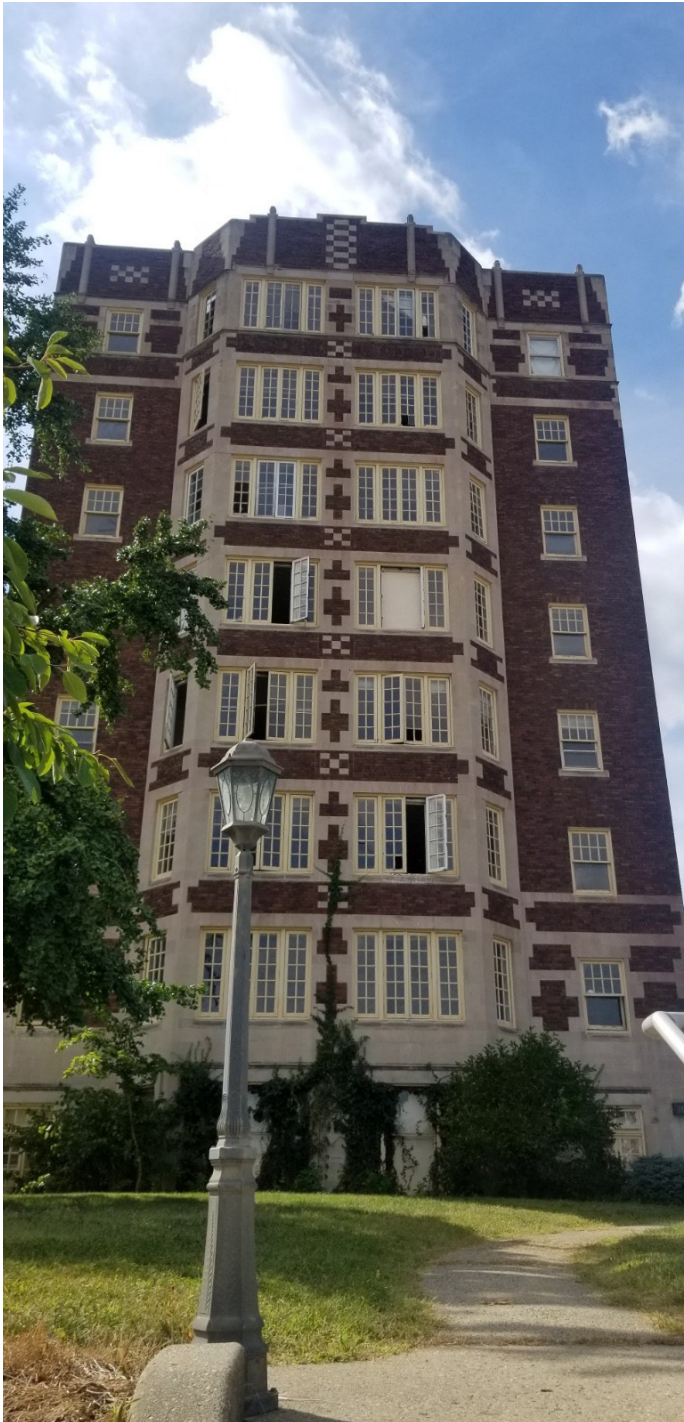
Fig.1 East elevation. Photo: IHPC Staff, 2019

a limestone foundation and was built with fireproof construction. It has a reinforced concrete frame, concrete and tile floors and roof, and 12-inch brick and tile curtain walls. Pyrobar was originally used for interior partitions, as well as the stair and two elevator shafts. On the primary east façade, limestone rises from the foundation to the second floor before transitioning to red brick walls. The north, south, and west elevations are primarily red brick walls with limestone embellishments and limestone sills. Brick, tile, and limestone are laid in geometric patterns on the east façade; these motifs are echoed at the top of the building on all four façades. The brick is laid in a running bond and limestone quoins are found on the corners of the primary eastern façade.

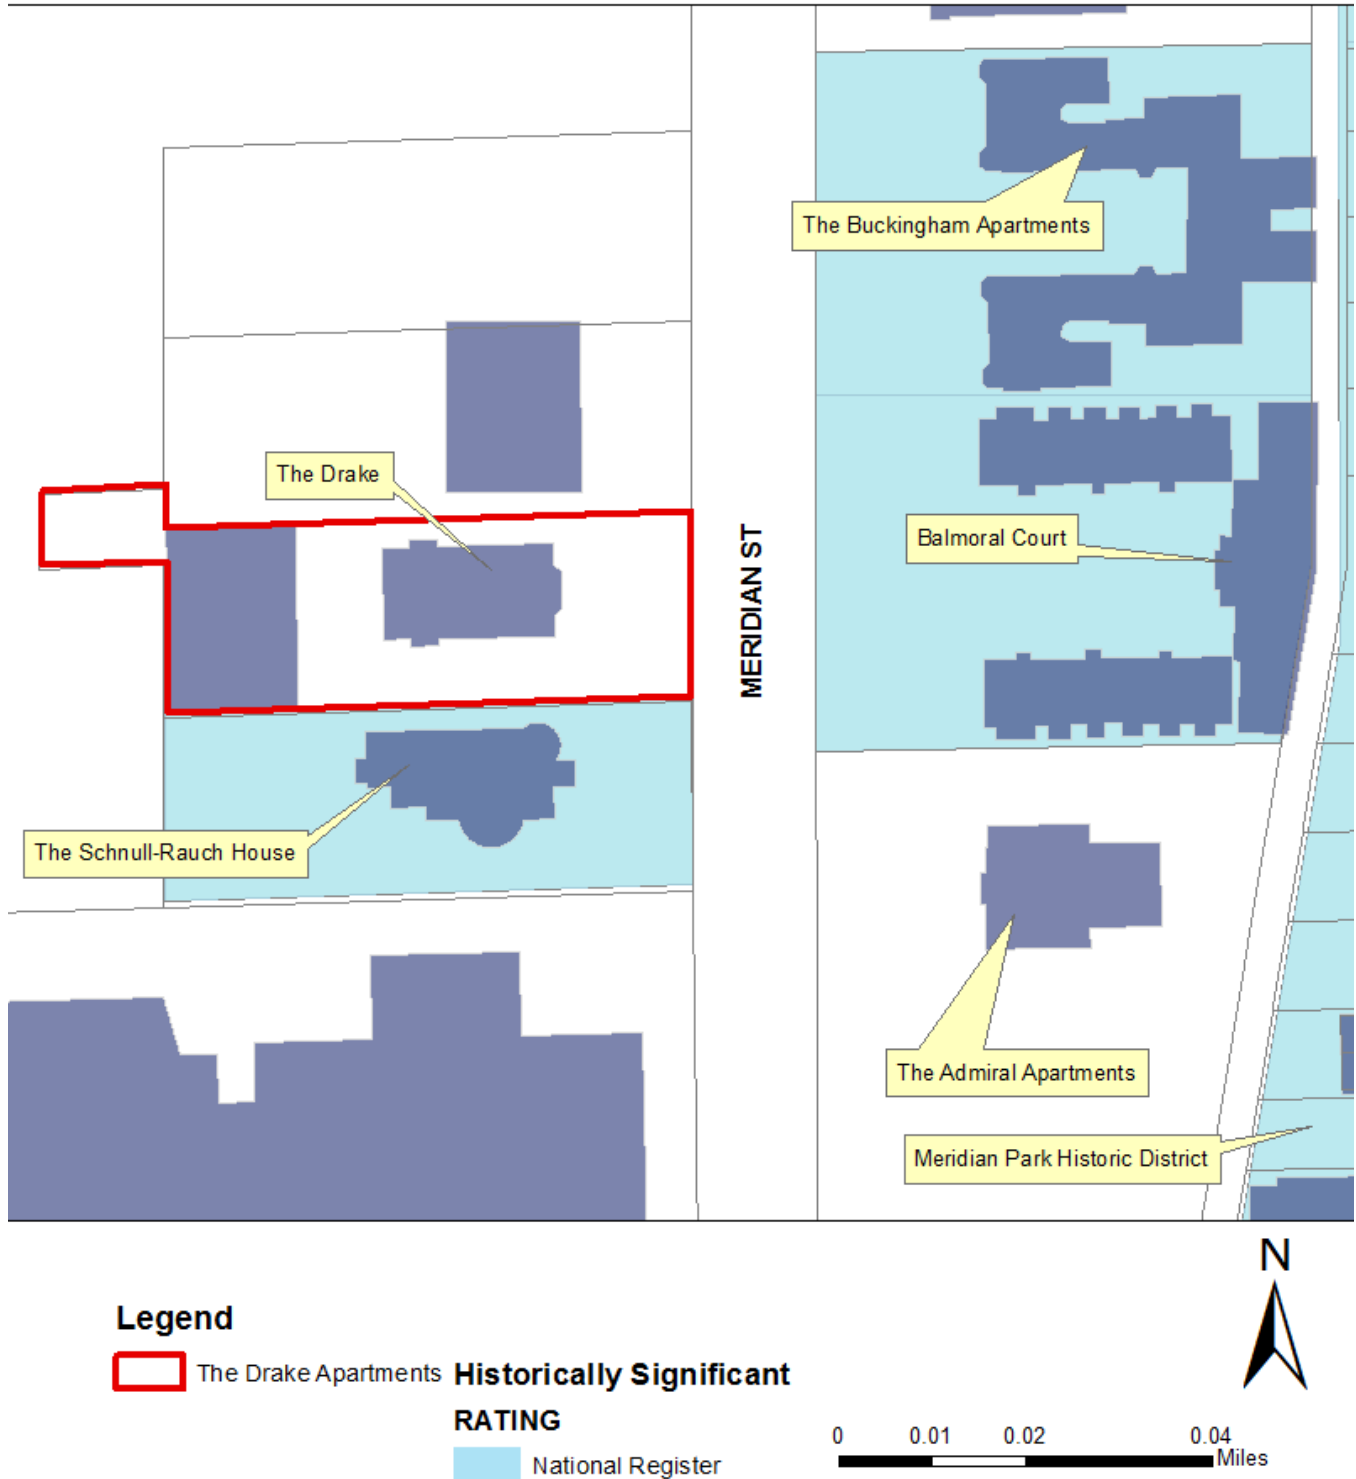
Fig.2 Boundary Map of Historic Area

# Boundary Map of the Historic Area-- The Drake Apartments

3060 North Meridian Street  
Center Township, Marion County, Indiana

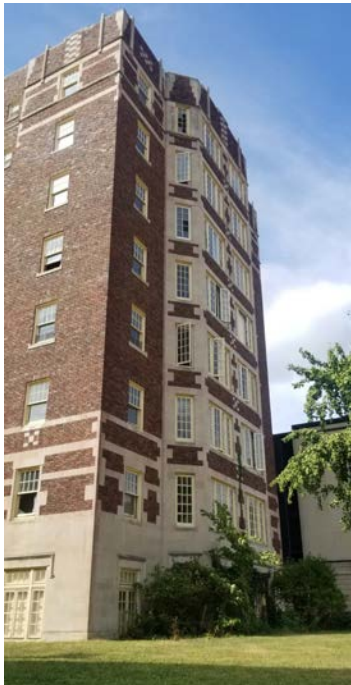
Fig.3 East and partial south elevations.  
Photo: IHPC Staff, 2019

The north and south façades are symmetrical. They both have nine bays. Beginning at the east corner on the north façade and the east corner on the south façade, bay six projects from the façade face. Limestone rises to cover the entirety of the first floor on both these bays and a limestone and brick checkerboard detail is centered at the top of these bays near the roofline. Double-hung, eight-over-one windows with limestone sills are found in each bay.

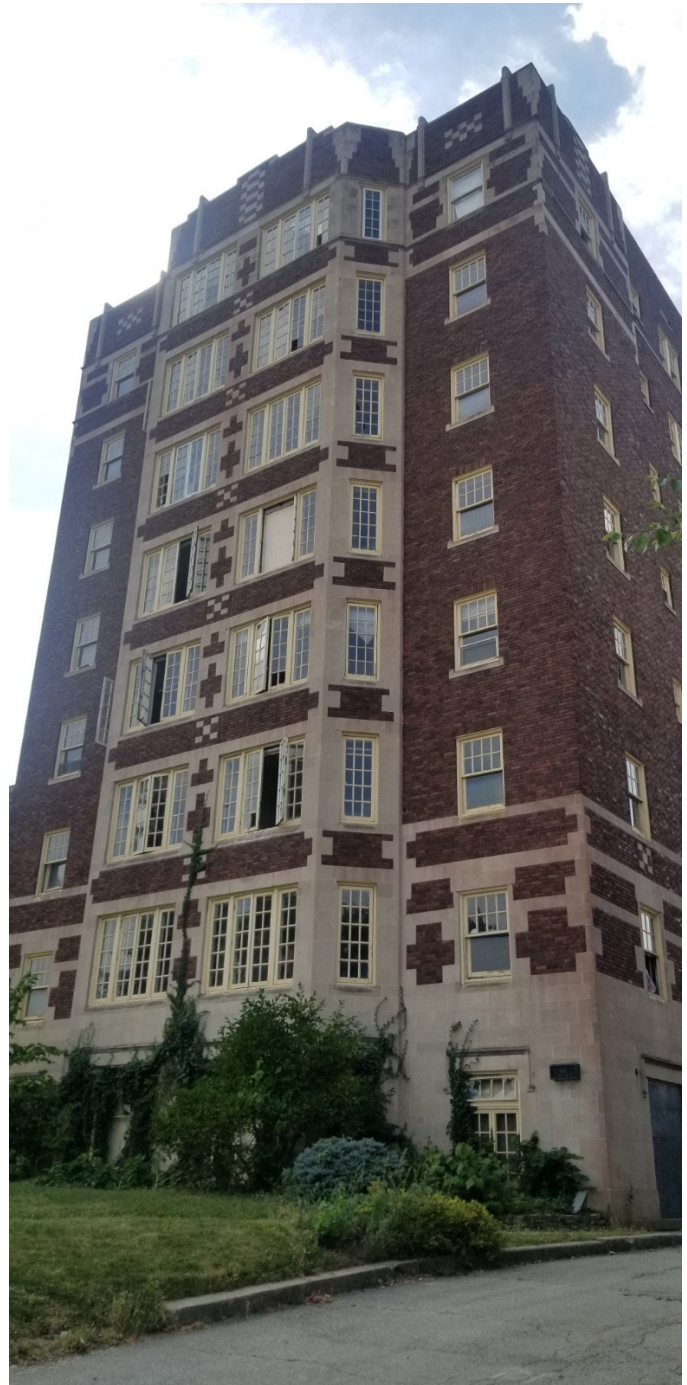
Fig.4 East and partial north elevation. Photo: IHPC Staff, 2019

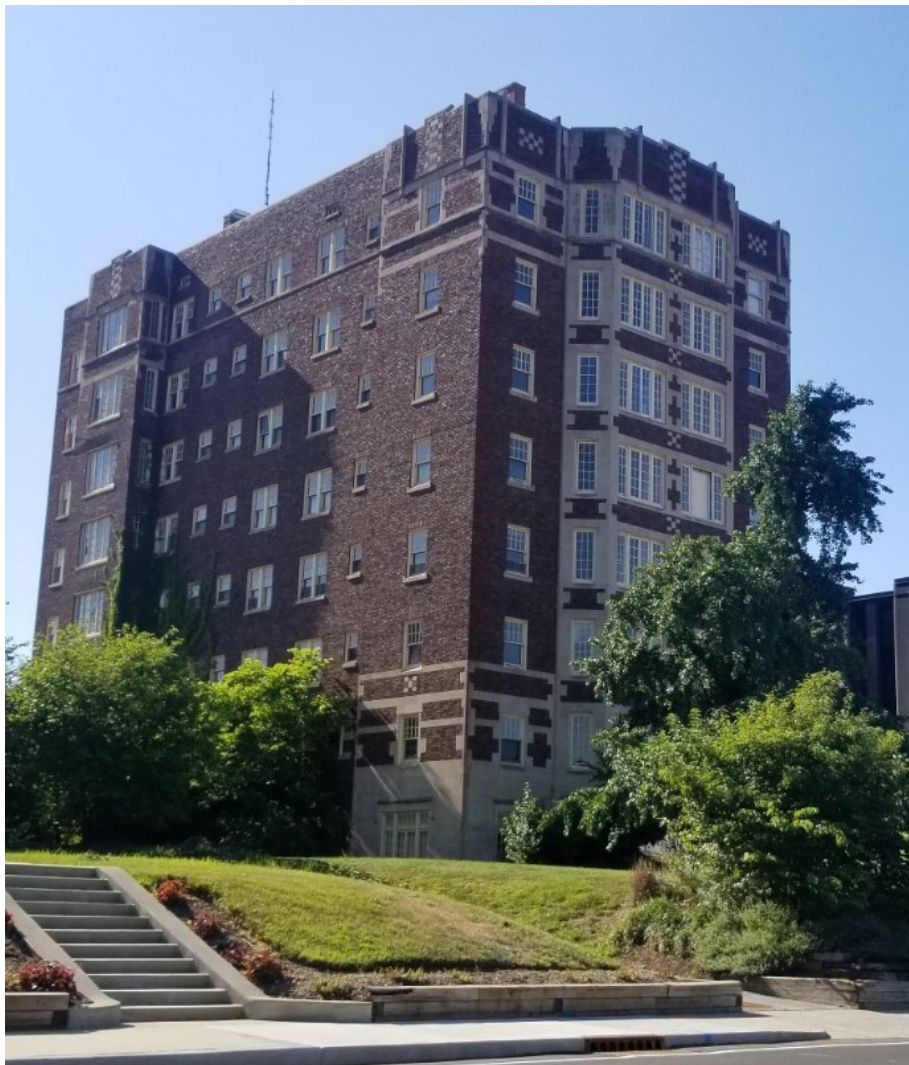
Fig.5 Southeast corner of the Drake Apartments as seen from North Meridian Street. Photo: IHPC Staff, 2019
